Subject:  
Former Plainwell Impoundment and Plainwell No. 2 Dam Area 2012 Bank Conditions  
Monitoring Report - Addendum 2

# Former Plainwell Impoundment TCRA

Documentation of Bank Maintenance  
Work Completed along the South Bank  
of the Western Channel (Item 3. e. in  
the US EPA Memorandum dated  
December 7, 2012) Completed on  
February 14, 2013

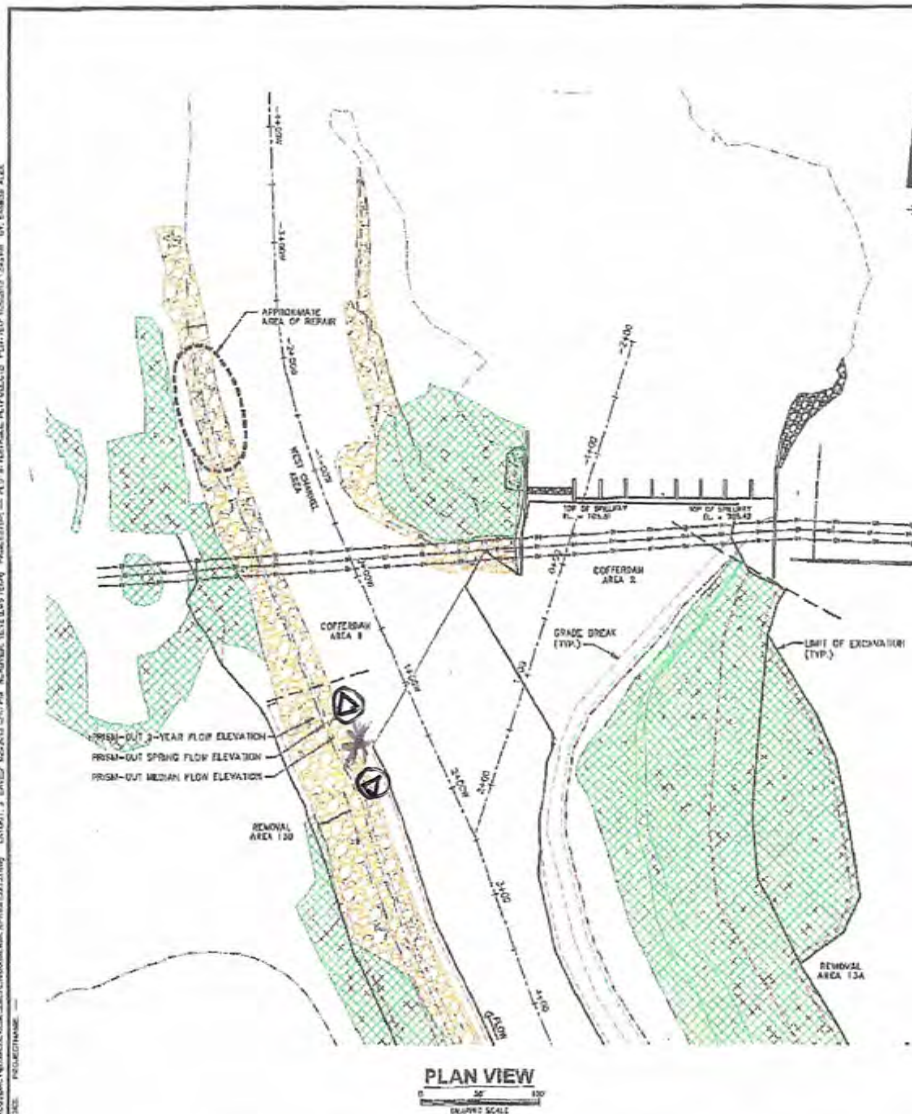
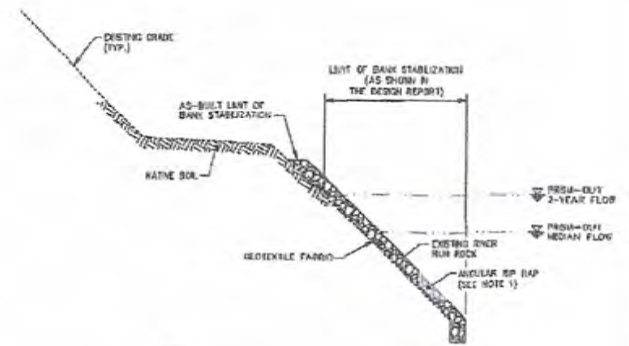
The bank maintenance consisted of placing additional armor rock near the water line in three areas over a combined 120 feet of river bank. The three areas as identified on the attached Figure 3 consisted of:

1. Area described in section 3 (e) - ~30 feet in length, where armor rock was placed about 2 feet thick starting below the water line and extending up the bank about 8 feet.
2. An area about 40 feet upstream - ~15 feet in length, where armor rock was placed about 1 foot thick starting below the water line and extending up the bank about 5 to 6 feet.
3. An area about 20 feet downstream - ~15 feet in length, where armor rock was placed about 1.5 feet thick starting below the water line and extending up the bank about 5 to 6 feet.

Ⓐ upstream and downstream limits on Feb. 14, 2013 bank maint.

\* approximate location. Comment 3(Ⓐ), adjacent to downstream end of prism.

Existing armor rock located at the highest portion of the bank was used for the maintenance work. Photos of the three maintenance areas are also attached.

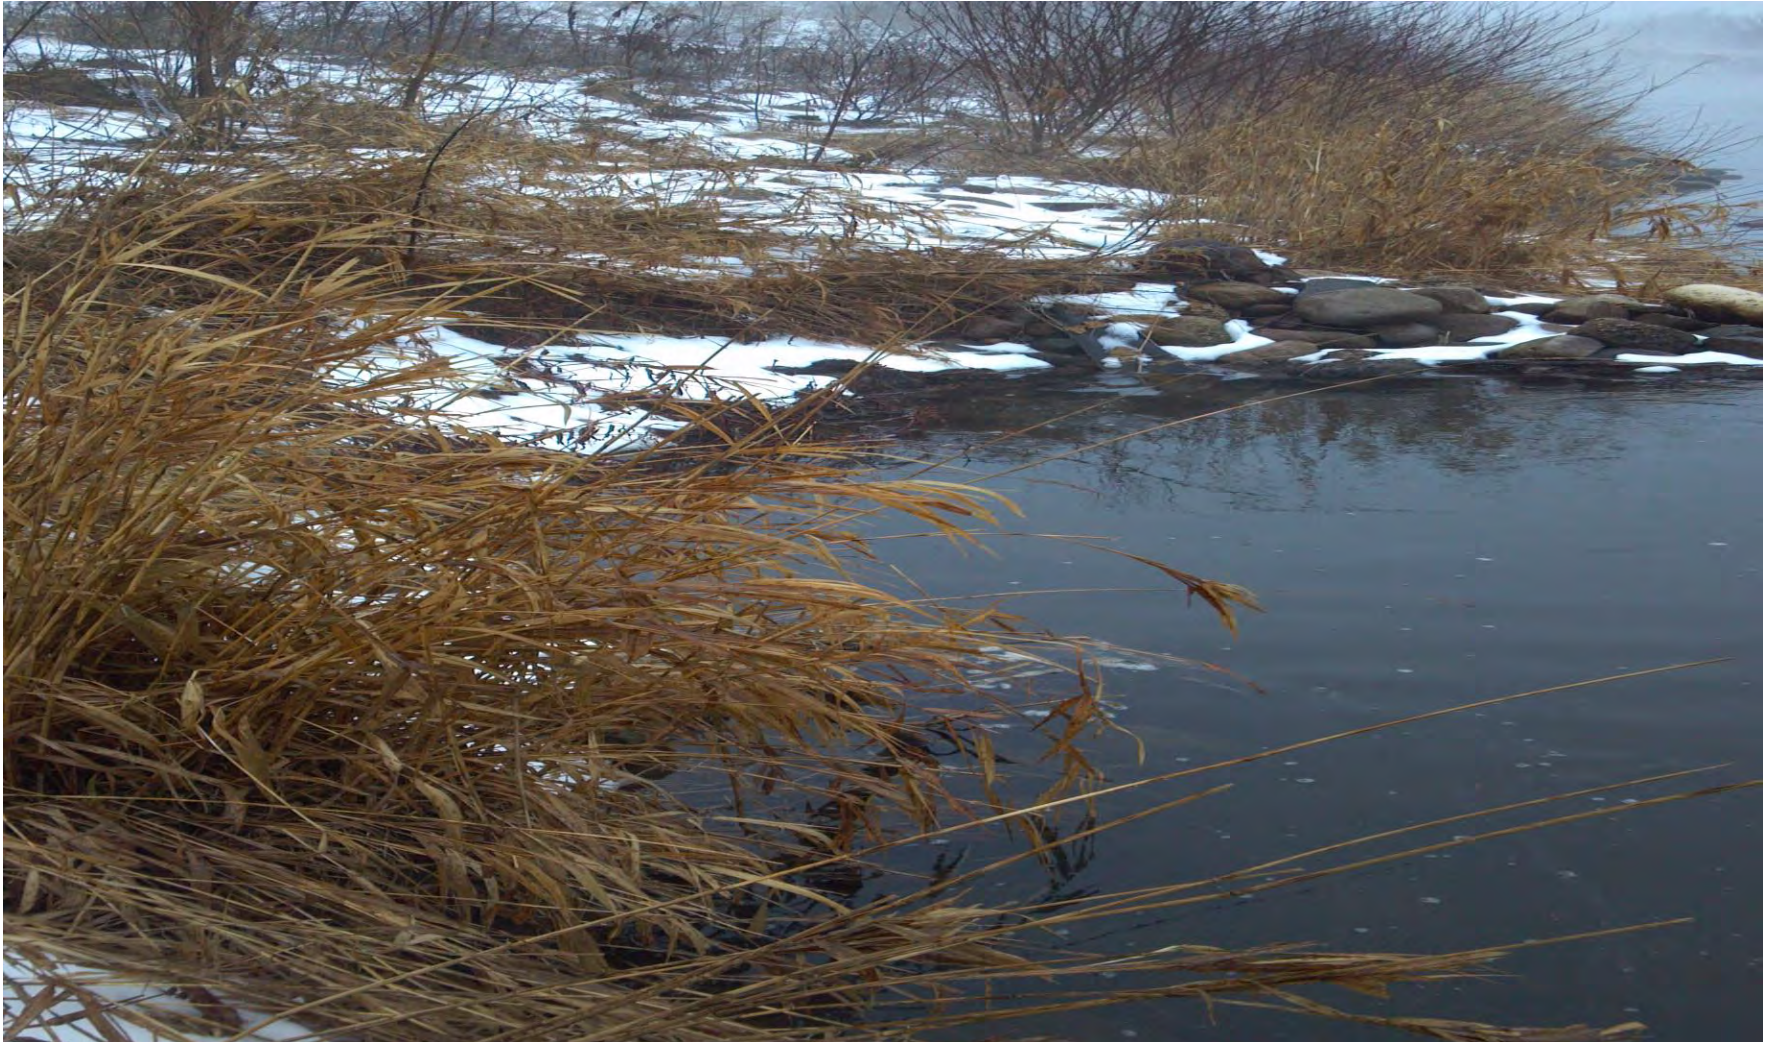
# Area 3 (e) prior to bank maintenance

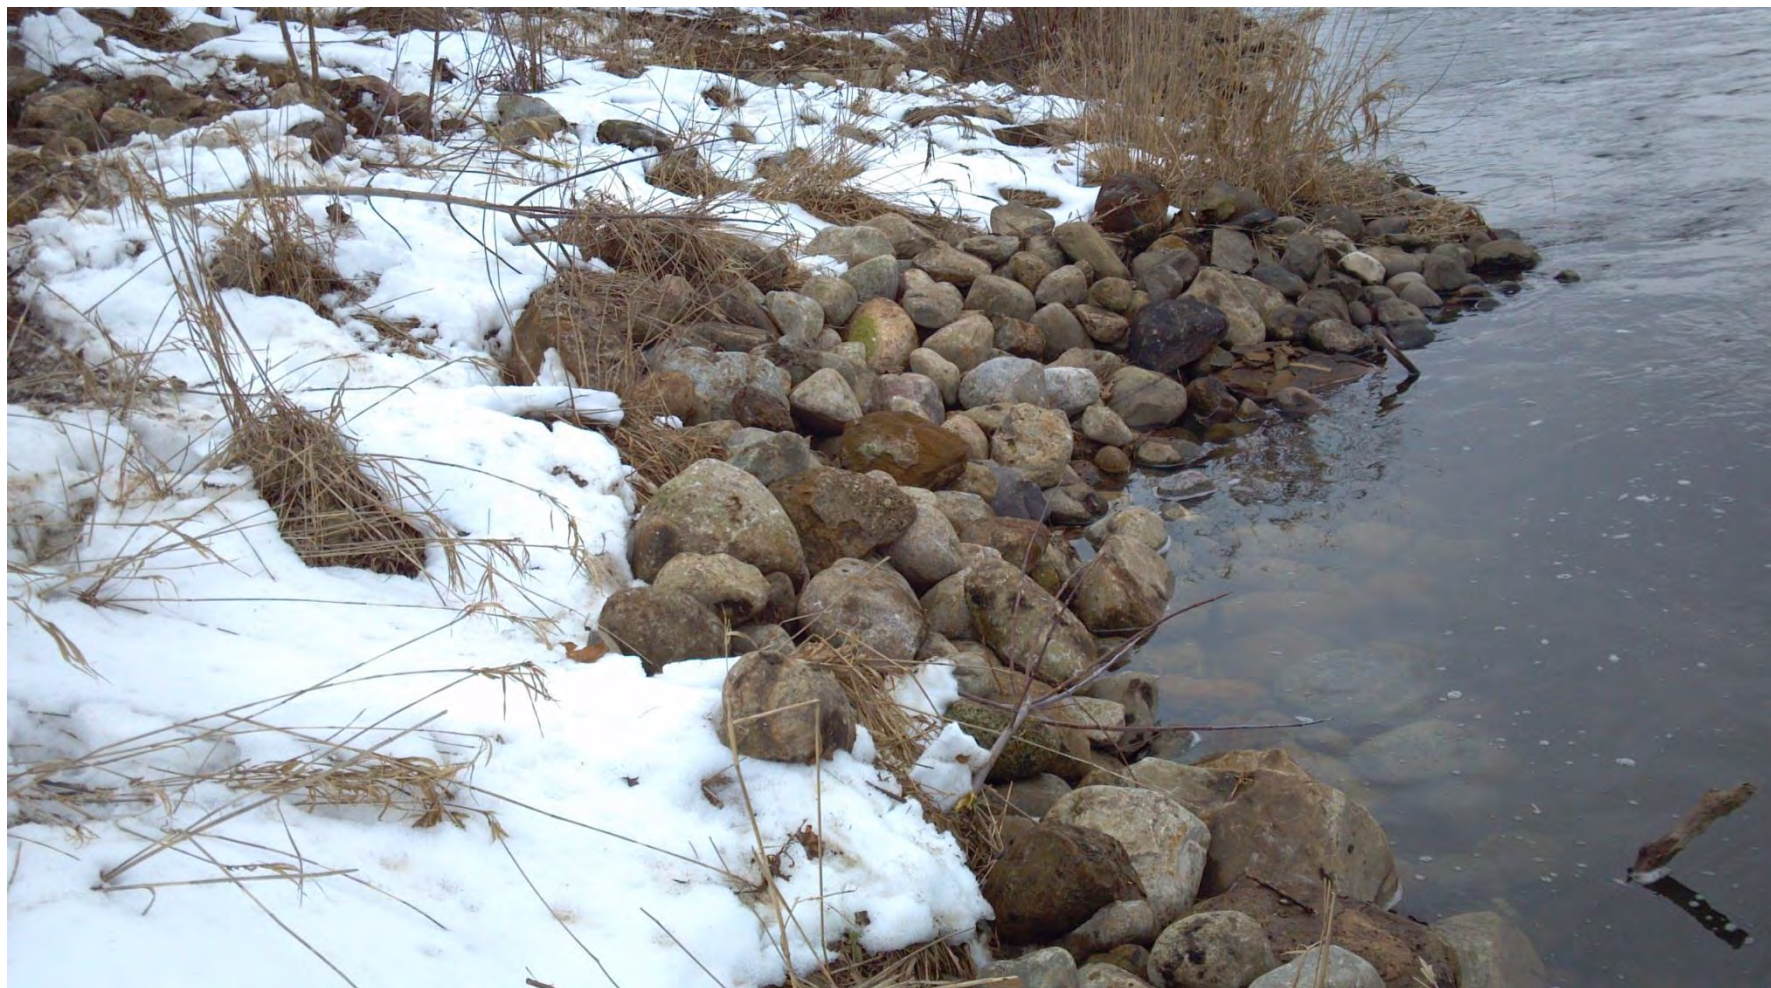
# Area 3 (e) after bank maintenance

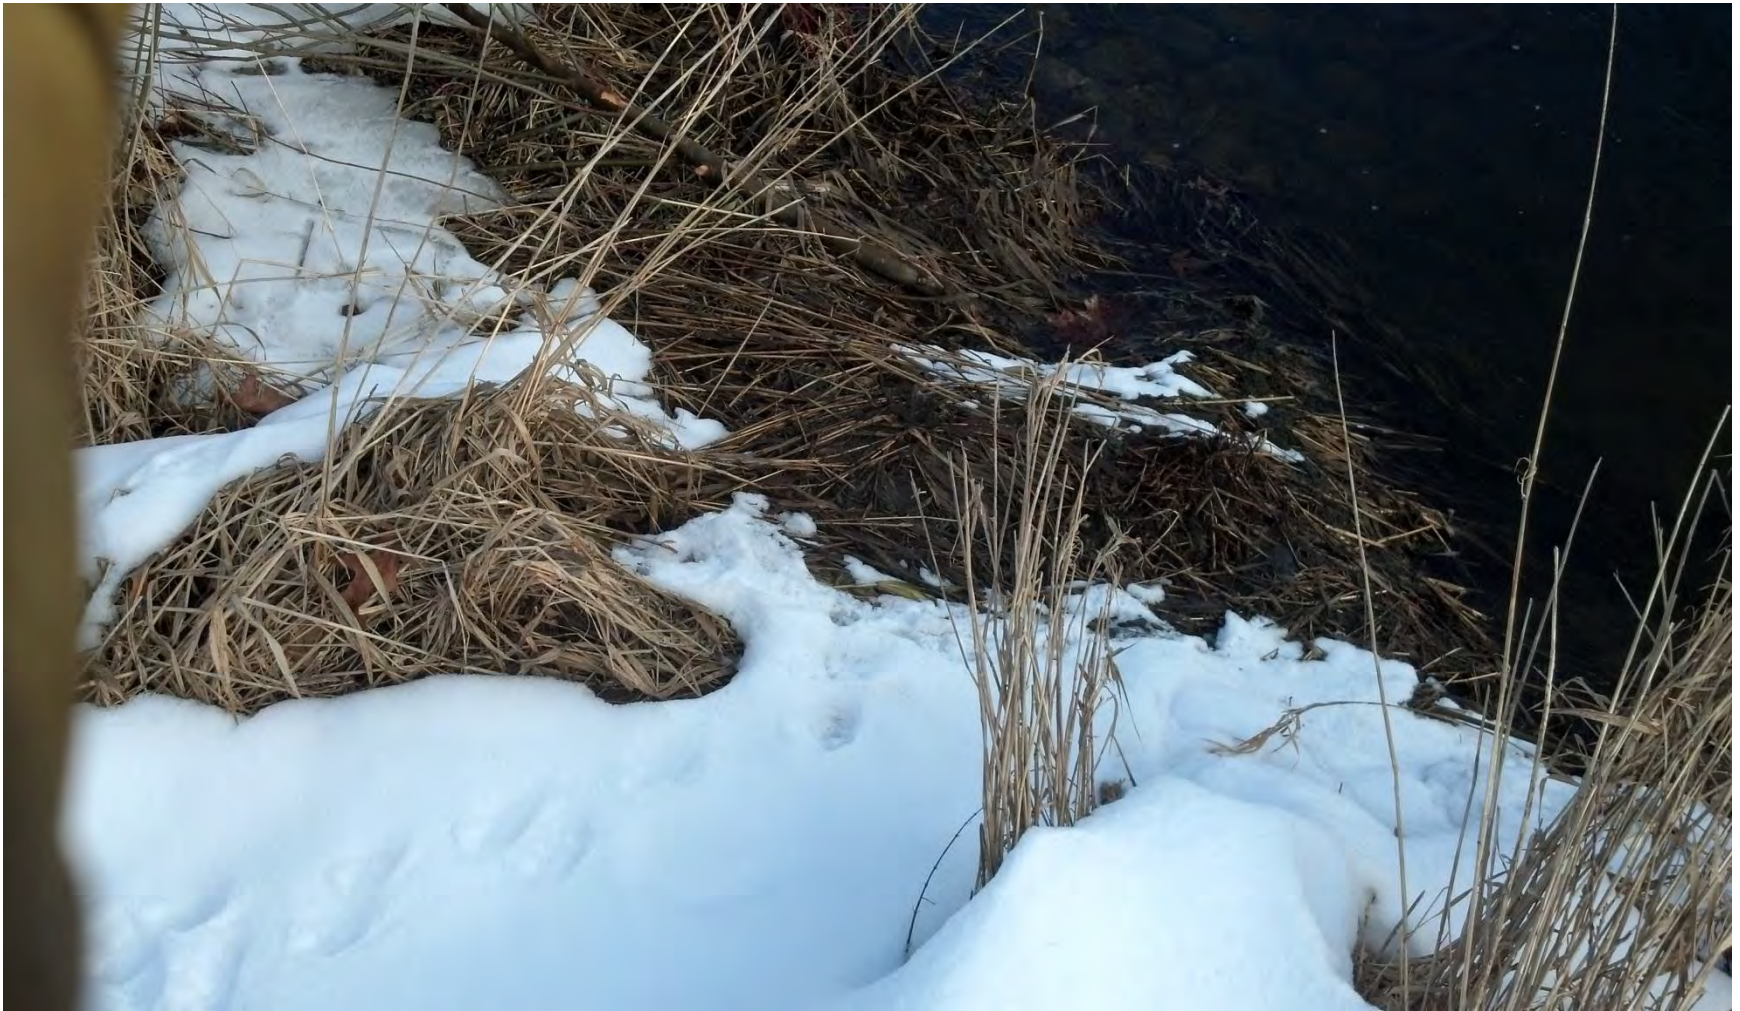
# Area upstream of area 3 (e) prior to bank maintenance

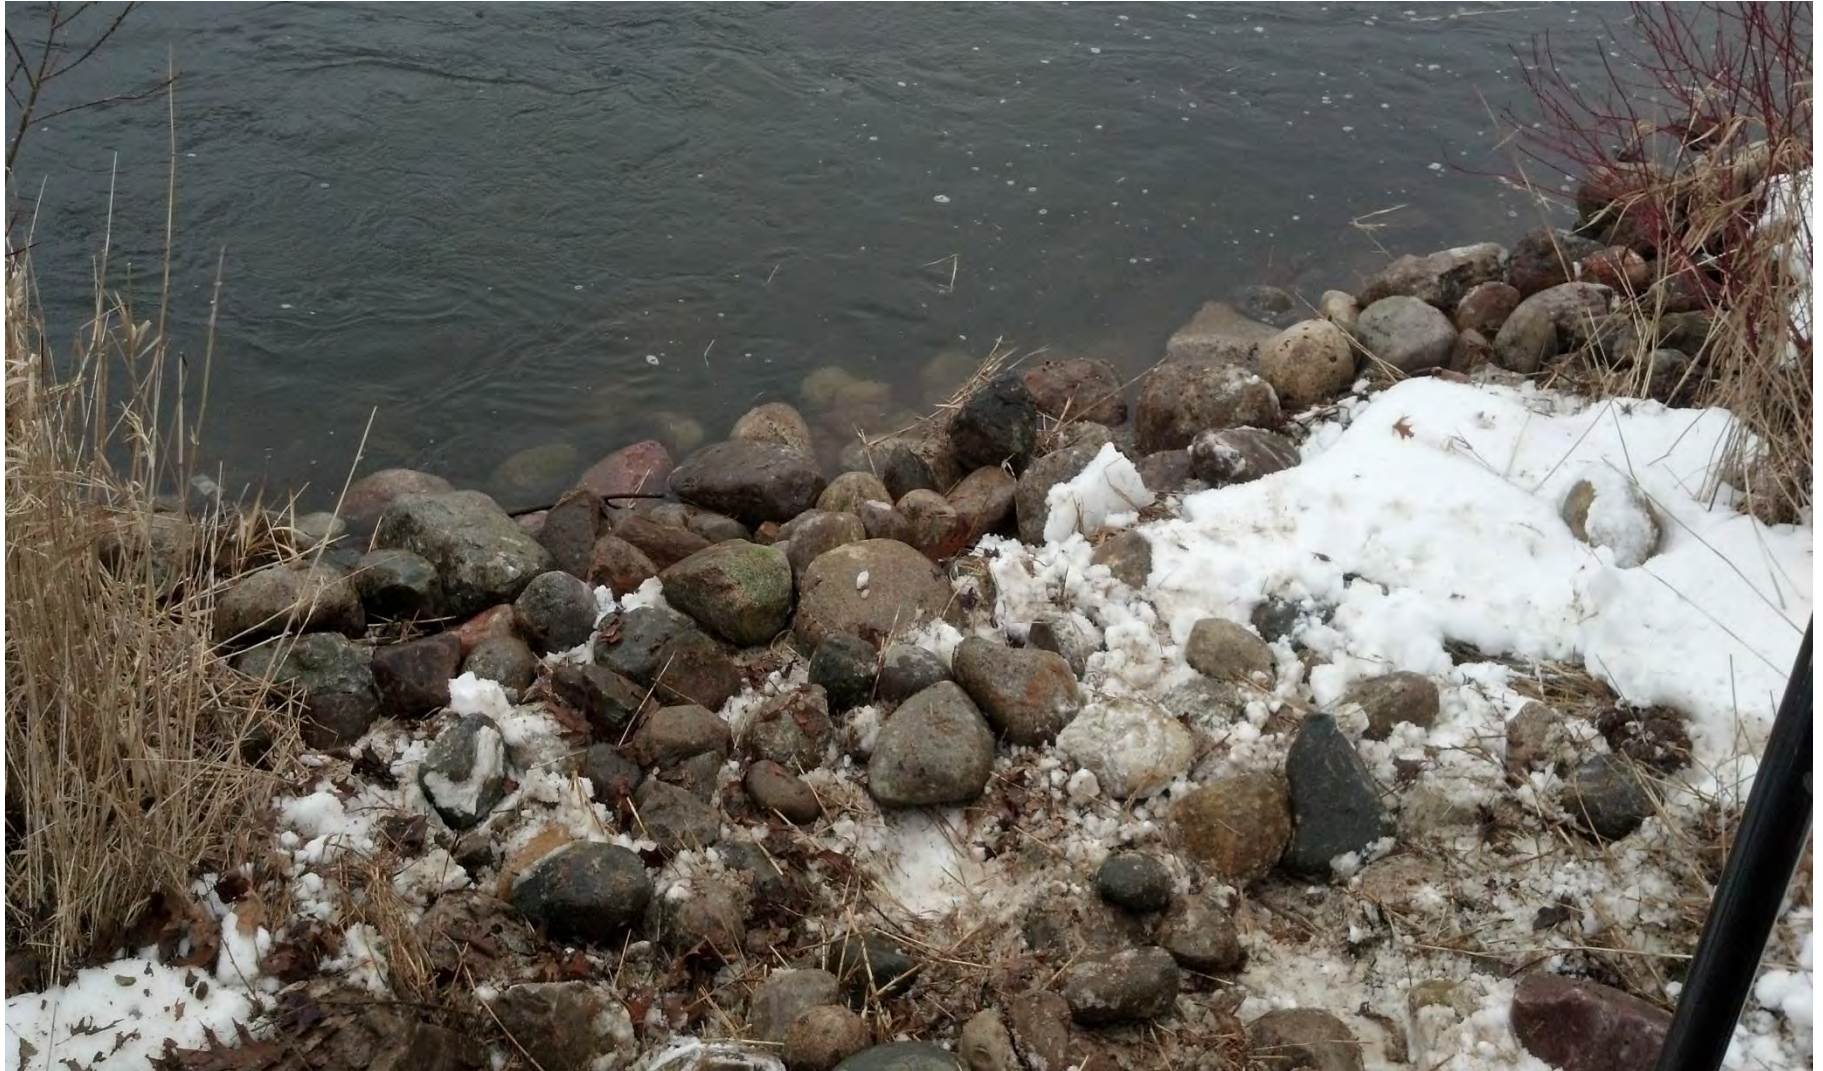
# Area upstream of area 3 (e) after bank maintenance

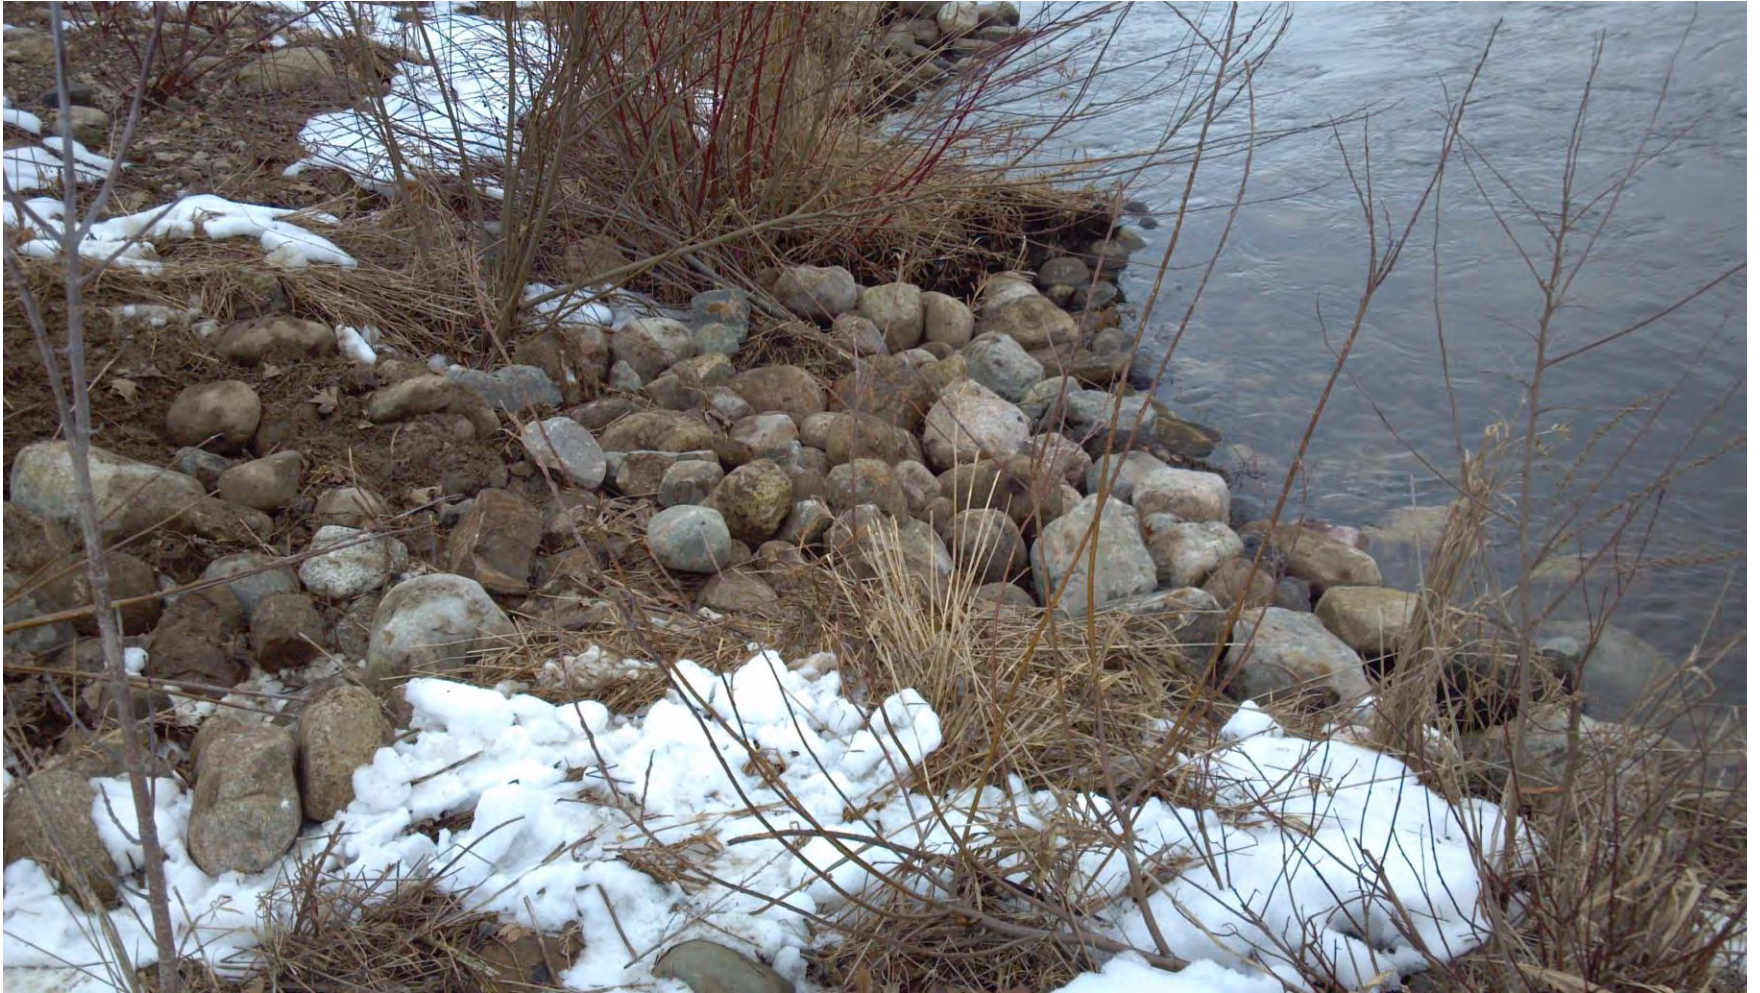
# Area downstream of area 3 (e) after bank maintenance
